# Il motore turboelica Catalyst: — tecnologie innovative e sviluppo tecnologico

— Sergio Salvano, Executive, Engineering Section  
Catalyst Product Line  
24 oct 2024

# Catalyst engine... the game changer turboprop

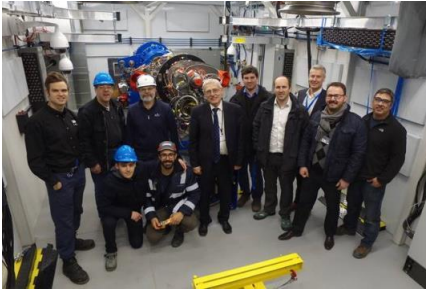
## FETT

- ✓ Full power to xx shp
- ✓ Max rate transients
- ✓ Aero mech VG sweeps
- ✓ Broken pipe test
- ✓ Part/full power operability/stalls
- ✓ Flameout and relight
- ✓ IR camera
- ✓ Smoke test
- ✓ Dirty layout

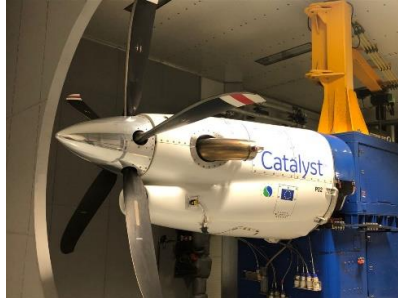
## Altitude

- ✓ Envelope steady state points
- ✓ Transient performance
- ✓ Operability pinch points
- ✓ Altitude relight tests
- ✓ Cold soak starts
- ✓ Conditions tested up to xx k ft

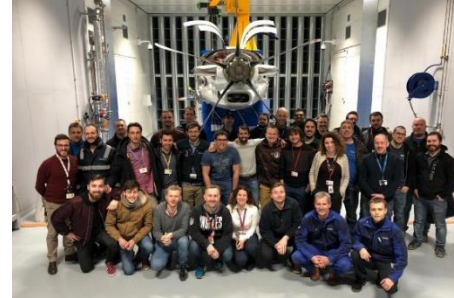
## Engine Vibe Practice

- ✓ First test with Prop
- ✓ Propeller control system verification
- ✓ Fast manouvers & Reverse
- ✓ Max Field imbalance on all rotors
- ✓ Vibe surveys
- ✓ Stair-step & dwell test
- ✓ Dirty layout

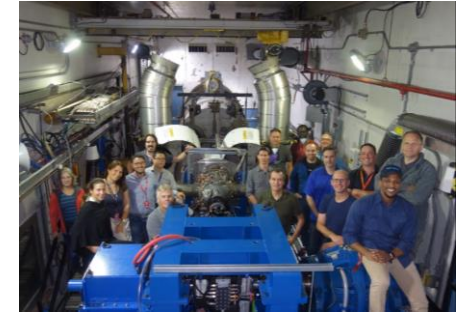
## Practice Small bird Ingestion

- ✓ Small bird practice test
- ✓ No operability or dynamics issues post the event

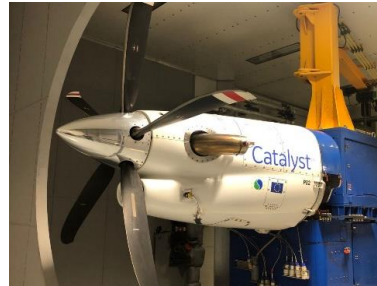
## Blade Out Practice

- ✓ HP R1 blade release w/same requirements as cert test;
- ✓ Blade release exceeded redline speed

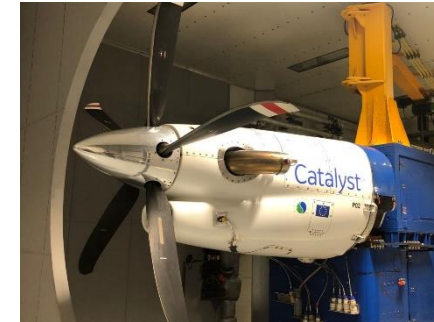
## SoF & Practice Endurance

- ✓ PGB vibe surveys & dwell
- ✓ High power feather
- ✓ FADEC power loose
- ✓ Oil interruption
- ✓ Endurance test

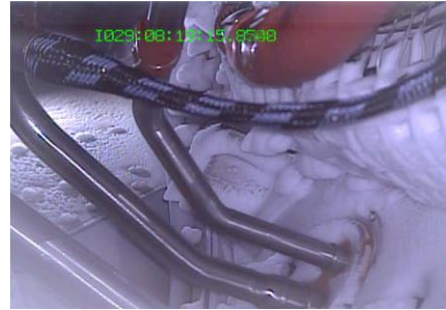
## Icing Certification

- ✓ 11 certification icing points executed
- ✓ Minimum temperature reached
- ✓ 8 engineering icing points executed
- ✓ Engineering tests performed: Impeller dwell, bow rotor, high power stalls

| Reg. | Test Name | Test Engine | Status |
|---|---|---|---|
| 33.68 | Induction System Icing | 148009/01A | Completed |

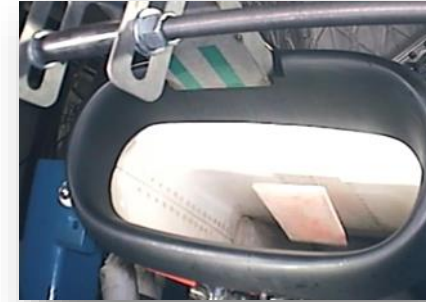
## Ice slab ingestion

- ✓ Foreign object ingestion (Ice) – 33.77
- ✓ No detrimental effects occurred during the ice slab ingestion and no engine deterioration noted after the event (Pcal)

| Reg. | Test Name | Test Engine | Status |
|---|---|---|---|
| 33.77 | Ice Slab Ingestion | 148009/01B | Completed |

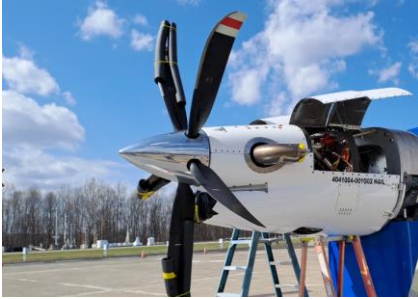
## Engine Vibration Test

- ✓ Vibe Sweep up to Ng and Np red line
- ✓ Stair Step and dwell for 33.63
- ✓ PGB certification for 33.83

| Reg. | Test Name | Test Engine | Status |
|---|---|---|---|
| 33.63 | Engine Vibration | 148002/05A | Completed |

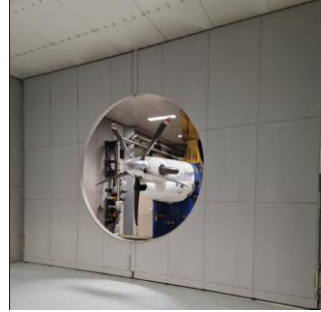
## Endurance Test

- ✓ Triple Red Line conditions
- ✓ 25 x 6 hours endurance cycles
- ✓ Test run in the same facility as a practice test
- ✓ Engine teardown completed.

| Reg. | Test Name | Test Engine | Status |
|---|---|---|---|
| 33.87 | Engine Endurance | <u>148003/02B</u> | Completed |

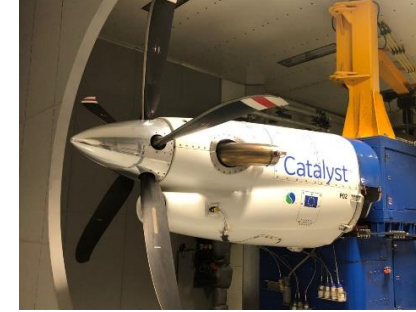
## Blade Out Test

- ✓ HP R1 blade released above Ng redline speed as intended
- ✓ Blade contained, no fire, no damage to mounts

| Reg. | Test Name | Test Engine | Status |
|---|---|---|---|
| 33.94 | Blade Containment | <u>148014/01A</u> | Completed |

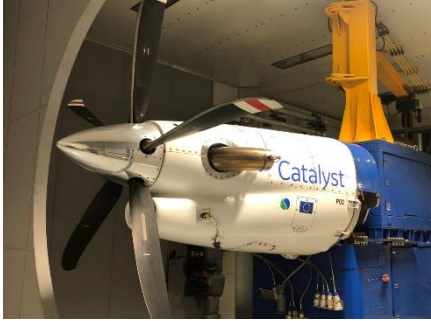
## IMI

- ✓ 33.90 – Total 2000+ c-cycles
- ✓ Teardown/layout complete

| Reg. | Test Name | Test Engine | Status |
|---|---|---|---|
| 33.90 | IMI | 148004/01B | Completed |

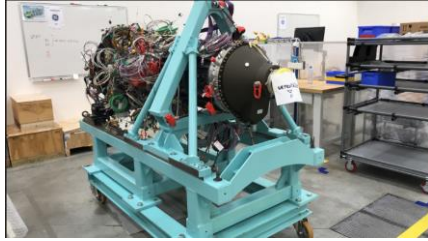
## PT Vibration test

- ✓ Rotating strain gages on PT blades and rotors
- ✓ Aeromech sweep with run above RL speed
- ✓ Mapping of power of PT operating range speed vs torque (engineering test)
- ✓ PT Thermal surveys (engineering test)

| Reg. | Test Name | Test Engine | Status |
|---|---|---|---|
| 33.83 | PT Rotor System Vibration | 148006/01B | Completed |

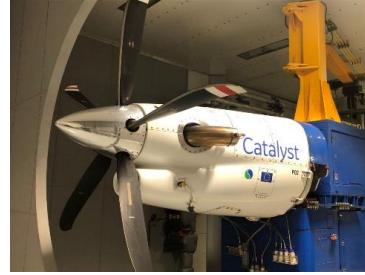
## Op/power response/oil inter./ fault ing, overtemp

- ✓ 33.65 Surge & stall
- ✓ 33.73 Power response
- ✓ 33.89 Operations
- ✓ 33.71 Oil interruption
- ✓ 33.28 Engine fault ingestion
- ✓ 33.95 Engine-Propeller Systems Tests
- ✓ 33.88 - overtemperature
- ✓ Engineering operability test

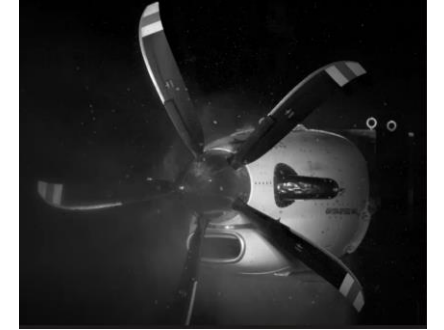
## Hailstorm Ingestion

- ✓ Hailstorm mechanical damage – 33.78

| Reg. | Test Name | Test Engine | Status |
|---|---|---|---|
| 33.78 | Hail Ingestion | 148009/01D | Completed |
